TOOL FAILURES -CAUSES AND PREVENTION

I. Jung

H.-J. Wieland

Verein Deutscher Eisenhüttenleute

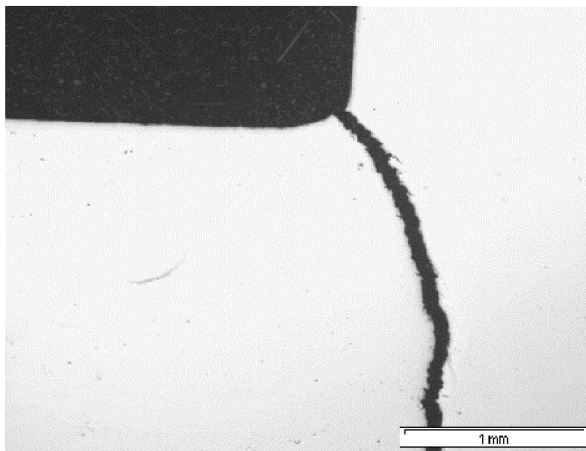
Design failures. One common design failure are sharp edged radii which cause a pronounced notch effect when the tool is operated under load and may cause it to break if its tensile strength is exceeded. An example of such flawed design is illustrated in Fig.3. The product in question is a die insert made of a hardenable corrosion resistant high wear chromium alloy die steel (BÖHLER M 340). Cracking has occurred due to the high notch stress along the sharp edged radius. This might be remedied by providing a maximum radius in all load bearing areas. Another effective reduction of the radius notch effect can be achieved by polishing the radius surfaces. If these measures should still not give an adequate fracture resistance, a tougher material must be used.

Figure 3. Crack initiation at the sharp radius of a plastic mould die of a hardenable corrosion resistance plastic mould steel.

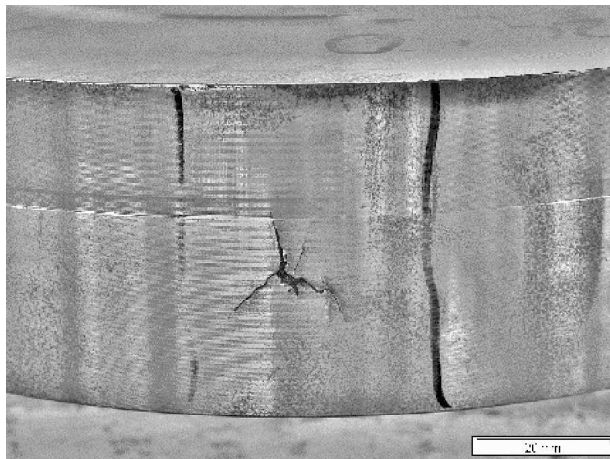
cracks) has been on the increase again in recent years, as shown here for a HS6-5-2C (material No. 1.3343) steel bar in Fig.4. Material failures of this type are found specifically in steels from CIS countries and emerging Asian markets. The damage caused by such material defects is particularly high since they will usually entail substantial consequential costs, e.g., machining costs, production shutdowns, and the like. The loss to the overall economy is considerable, although the material costs of a contemporary tool will usually account for only 5% of the defect costs described.

Figure 4. Forging failure at the outer surface of a round bar (253 mm Ø) of steel grade HS6-5-2C (steel number 1.3343).

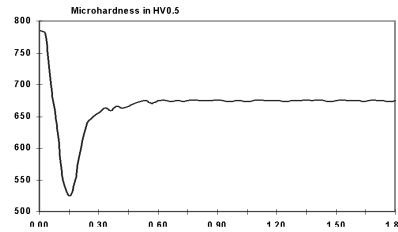
and may propagate into the basic microstructure. The hardness distribution in a surface damaged by grinding is shown in Fig.5b; the excessive hardness in the rehardened zone, the hardness drop in the underlying tempered zone and the subsequent hardness increase in the core structure are easily identifiable. These variations in structural conditions and hardness produce an unfavourable internal stress distribution, mostly accompanied by tensile stress, which renders the surface sensitive to cracking. The intensity of such stresses can be seen in Fig.5c: on this plate made of 90MnCrV8 steel (material No. 1.2842), high tensile stresses in the surface have caused a large area to chip off and rise up several millimetres. The only way to prevent microstructural damage during grinding is to provide adequate cooling. It should be noted here that in terms of cooling performance, today's grinding emulsions with their increasingly high water content, a concession, *inter alia*, to environmental concerns appear to be more inferior to emulsions with higher oil content than has so far been assumed. The minimal lubrication principle widely adopted today additionally imposes higher heat loads on the ground surface, thus increasing the risk of rehardening.

(b) Variation in hardness within the hardening zone of the grooved roll in Fig.5a.

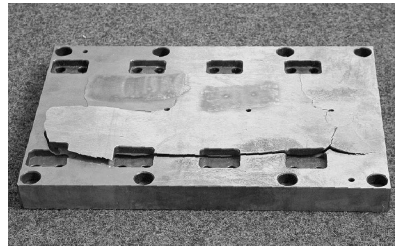
(c) Crack initiation during spark erosion due to high internal stresses, caused by grinding without sufficient cooling (hardened and tempered plate of steel grade 90MnCrV8 (steel number 1.2842).

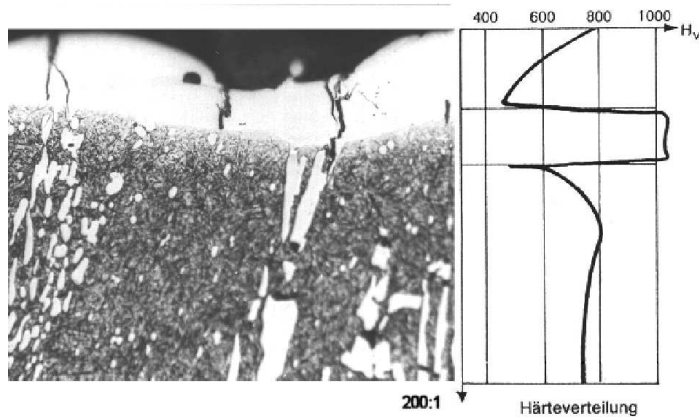
Erosion failures. Erosion machining with excessive power inputs is another widespread cause of failure. Especially with highly alloyed tool steels, excessive power levels may give rise to significant surface damage. Fig.6 shows a metallographic specimen of the coarsely spark-eroded surface of a high alloyed cold work steel grade. The extensive melted zone, with incipient cracks due to thermal overloading, is clearly identifiable. Underneath it we can see a rehardened zone consisting of brittle tetragonal martensite, as in the case of the grinding defect outlined above. The incipient cracks in the melted zone subject to tensile stress may easily propagate under load into the brittle rehardened zone; they frequently extend along the carbide bands, as will be easily appreciated from Fig.6, and will ultimately cause the tool to fail. As with grinding failures, we can observe an uneven hardness distribution along the eroded surface. Fig.6 illustrates the high hardness of the melted zone, the even greater hardness of the underlying rehardened area, the hardness drop in the underlying highly tempered area, and the following gain in hardness toward the core microstructure. Here too these inhomogeneous structures and hardness levels create an unfavourable internal stress situation.

Figure 6. Spark eroded surface mit significant melting zone, new hardened zone and high tempered area of a high alloyed cold work tool steel. Microstructure and variation in hardness.

This situation can be remedied by minimizing the power input into the tool during spark erosion. Continuous erosion under fine machining conditions, at low current and high frequency, is preferable. Following the erosion process, the product should be tempered again at about 30 – 50 K below the last tempering temperature to transform the rehardened zone into a tempered, tougher martensite. The melted zone should be mechanically abraded by grinding, polishing or micro peening.

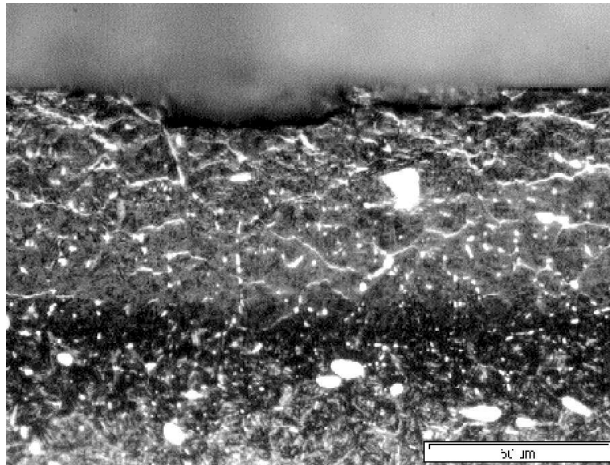
Nitriding failures. Tool steels are nitrided to increase the wear resistance of their surface. Another benefit of nitriding lies in the creation of subsurface compression stresses which protect against cracking. The increase in wear resistance is due to the penetration of nitrogen into the tool surface, although it must be said that with high alloyed tool steels, a "pile-up" of incoming nitrogen and the resulting formation of nitrides are a common risk. Such nitrides will form mainly at the grain boundaries, where the nucleation energy is minimal and more space is available due to lattice deformation. These grain boundary nitrides actually weaken the grain boundary, often to the point where entire grains become dislocated from the lattice, Fig.7. With higher alloyed tool steels, care must therefore be taken to prevent excessive nitrogen concentrations during nitriding. Optimum levels are easiest to achieve with plasma nitriding or fast acting nitriding solutions. Thus, nitriding is a process which yields high performance improvements when properly carried out, but may just as easily shorten the tool life when improperly applied.

Figure 7. Metallographical section through a overnitrided surface of a drawing die of steel grade X153CrMoV12 (steel number 1.2379) with significant nitride layers on the grain boundaries (Etchant: 3% HNO_3).

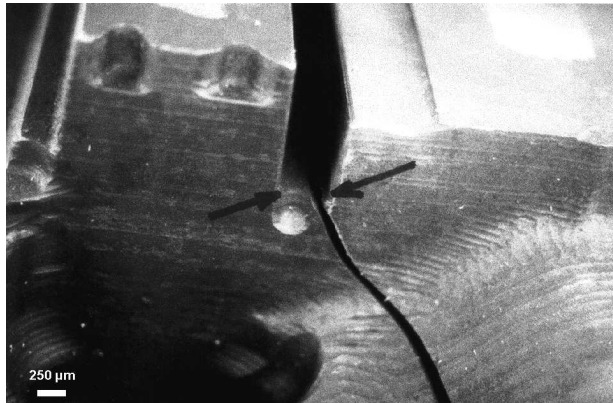
during quenching from the hardening temperature. It is facilitated by an unfavourable tool geometry, such as uneven mass distributions with pronounced differences in cross section, the notch effect of sharp edged radii, etc. Fig.8 shows a die made of X38CrMoV5-1 (material No. 1.2343) which is fairly large at $450 \times 195 \times 800$ mm; it was quenched and tempered to a working hardness of 46 HRC, corresponding to 1500 MPa. The heat treatment was conducted in a shielding gas atmosphere, with subsequent quenching in oil to room temperature. The quench stress crack shown here extends along a critical die contour with a sharp edged groove. Remedial measures in this case would have to include an optimized design of the die contour for the heat treatment, and a modification of the sharp edged groove. To reduce thermal stresses between the edge and the core, a soak cycle during the cooling phase or an "interception" at 150°C for subsequent tempering would be recommended.

Figure 8. Stress relieved crack of a die casting die of steel grade X38CrMoV5-1 (steel number 1.2343) following a sharp edged groove.

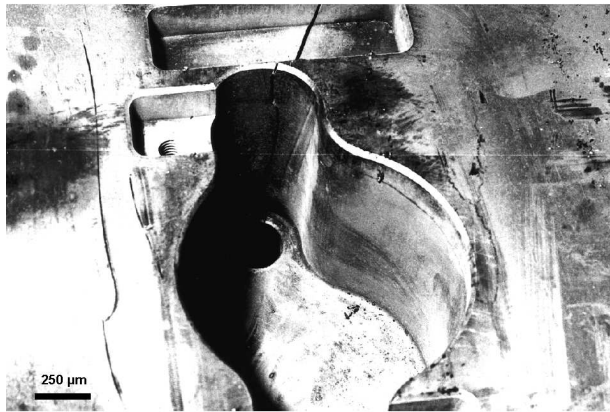
Another quench crack is illustrated in Fig.9. The tool in this case is a forging die made of grade X38CrMoV5-1 steel (material number 1.2343) which exhibits an unfavourable mass distribution as well as some extremely thin walls in its contoured area. The quench crack originates in the thin wall

of the contour which, to make matters worse, is quite sharp edged. The resulting notch effect, in conjunction with the high thermal stress encountered in the quench, is responsible for the formation of this defect. Here, too, a remedial strategy would have to focus on an improvement of the tool contour that eliminates sharp edged radii and major thickness differences. Soaking to relieve thermal stresses would be recommended.

Figure 9. Stress relieving crack of a forging die with extreme varying cross sections.

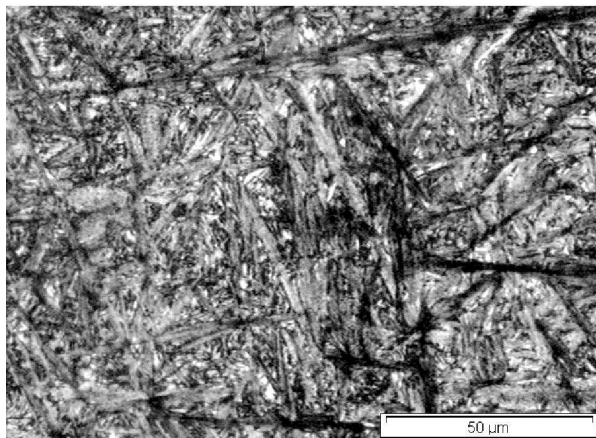
An unfavourable tempered microstructure may likewise give rise to quench stress cracking. Fig.10 presents the coarse-grained tempered structure of an aluminium die casting die made of 38NiCrMoV5-1 grade steel (material No. 1.2343) with a working hardness of 45 HRc. This tool exhibited a quench crack after heat treating, indicating a low toughness of the coarse-grained superheated structure. The die was heat treated at 1020°C with subsequent hot quenching at 180°C. It should be noted that in this case, no stress relieving was performed after the coarse machining step. The internal stresses introduced by the machining cycle thus further facilitated the formation of cracks. Remedial measures would have to include stress relieving at about 650°C after the machining step, a reduction of the heat treatment temperature to 1000°C, and the adoption of hot quenching at 550°C to reduce the risk of quench stress cracking.

Figure 10. Coarse martensitic quenched and tempered structure of a die casting die of steel grade X38CrMoV5-1 (steel number 1.2343) (Etchant: 3% HNO₃).

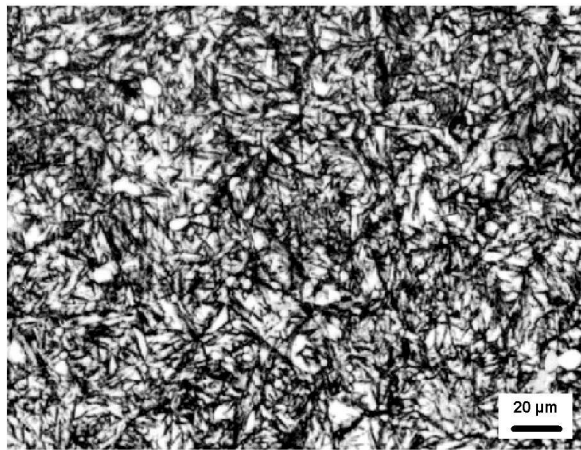
Fig.11 shows the coarse grained martensitic tempered structure of a cold forming die (140 mm diameter) made of X155CrVMo12-1 steel (material No. 1.2379). At 30%, the retained austenite level in this tool is quite significant. The failure of this die occurred soon after it was commissioned; it fractured along its interior radius. The hardness of this structure is 61 HRC, it was heat treated under vacuum (5 bar) at 1040°C with two tempering cycles at 540°C. The hardening and tempering steps were performed as part of a single cycle under vacuum. The root cause of the failure in this case was the high portion of retained austenite which was apparently able to stabilize due to a too slow passage through the martensite stage; moreover, the tool was not allowed to cool down to a sufficiently low temperature after the hardening process and between tempering cycles. To achieve a full martensitic transformation, the quench rate would have to be increased by raising the gas pressure and adopting a more loosely spaced furnace load envelope. After the hardening process and between tempering steps, the product should be allowed to cool down to room temperature to enforce the fullest possible martensitic transformation, particularly after the hardening step. Experience has shown that a common hardening and tempering cycle under vacuum does not favour the achievement of a full martensitic transformation. For economic reasons, the cooling phase after the hardening step and between tempering steps is often set too short; the furnace is frequently fired up for tempering again as soon as the product has cooled to 50 - 70°C. However, in vacuum hardening the product should ideally be quenched to room temperature as quickly as possible. Unlike the oil quenching process following brine hardening, in which the tools are transferred to a tempering

Figure 11. Martensitic hardening structure of a cold work die with large amounts of retained austenite (Etchant: 3% HNO_3).

furnace to prevent cracking by reheating to about 70°C, vacuum hardening itself entails no cracking risk since the process passes through the martensite stage much more slowly. As a result, the tool should be quenched to room temperature to achieve the fullest possible degree of martensitic transformation. If the martensite stage is passed too slowly and the tool cannot cool down far enough, stabilized retained austenite will remain present. It transforms but sluggishly and incompletely during the subsequent tempering stage, particularly if the tool is not allowed to cool to room temperature after the tempering cycles. The tendency for retained austenite to stabilize will become more acute with large tool dimensions and/or full furnace loads. With all tools made of cold work or high speed steels, which are expected to exhibit maximum toughness and high hardness at the same time, care should therefore be taken to provide maximum quench rates and a generous furnace load spacing. In the case of large hot work tools such as casting dies, an increased cracking risk lies in the high thermal stresses between the edge and the core, so that a hot bath soak cycle at about 500°C is recommended.

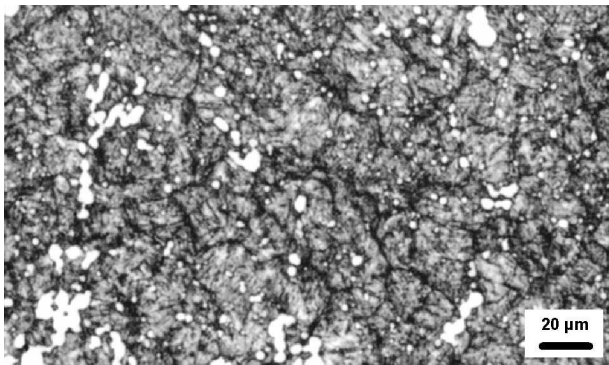
Another structural state often associated with an elevated cracking risk is inadequately tempered martensite. Its presence may be attributable to an insufficiently high tempering temperature, or to incomplete tempering at higher temperatures. Fig.12 shows such a microstructure in a hob cutter

made of HS6-5-2-5 steel (material No. 1.3243) and hardened to 66 HRC. This tool failed through premature tooth breakout. A large portion of inadequately tempered, only marginally stress relieved martensite is evident as a brighter structural area, particularly in the inner grain regions. On principle this deficient tempering state reflects the same mechanisms as the high retained austenite levels discussed above. But in this structure the retained austenite has already been transformed to martensite, part of which will be present in a sufficiently tempered state after the last tempering step. Due to the high portion of insufficiently tempered martensite, a microstructure of this type is extremely susceptible to fracturing, particularly at hardnesses exceeding 60 HRC.

Figure 12. Martensitic hardening structure of a hob of steel grade HS6-5-2-5 (steel number 1.3243) with insufficiently tempered martensitic structure (Etchant: 3% HNO₃.)

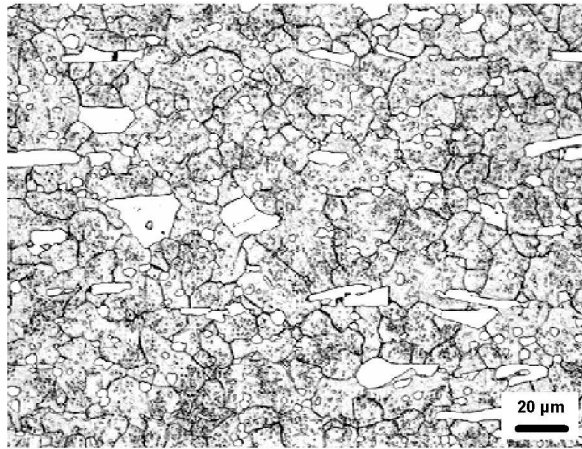
Grain boundary carbides. A reduced toughness in high alloyed tool steels will also be observed with microstructures of the type illustrated in Fig.13. The picture shows a $40 \times 40 \times 20 \text{ mm}^3$ stamping tool made of X153CrMoV12 grade steel (material No. 1.2379), quenched and tempered to 61 HRC, which fractured soon after its first use. The heat treated structure consists of an inadequately tempered martensite which additionally exhibits carbide banding along the grain boundaries. This pattern reflects too slow cooling in the proeutectoid carbide precipitation range between 800 and 600°C. Such carbide precipitation reduces the toughness of the material in the grain boundary areas and will often result in intergranular fracturing

under load. No handy remedy exists in this case, since the grain boundary carbides are virtually impossible to remove even by renewed heat treatment.

Figure 13. Low tempered hardening structure of a blanking tool of steel grade X153CrMoV12 (steel number 1.2379; D2-type) with carbides, layered on the grain boundaries (Etchant: 3% HNO_3).
